SERVICE BULLETIN 36

FCM controller board

Service Bulletin 36 instructions

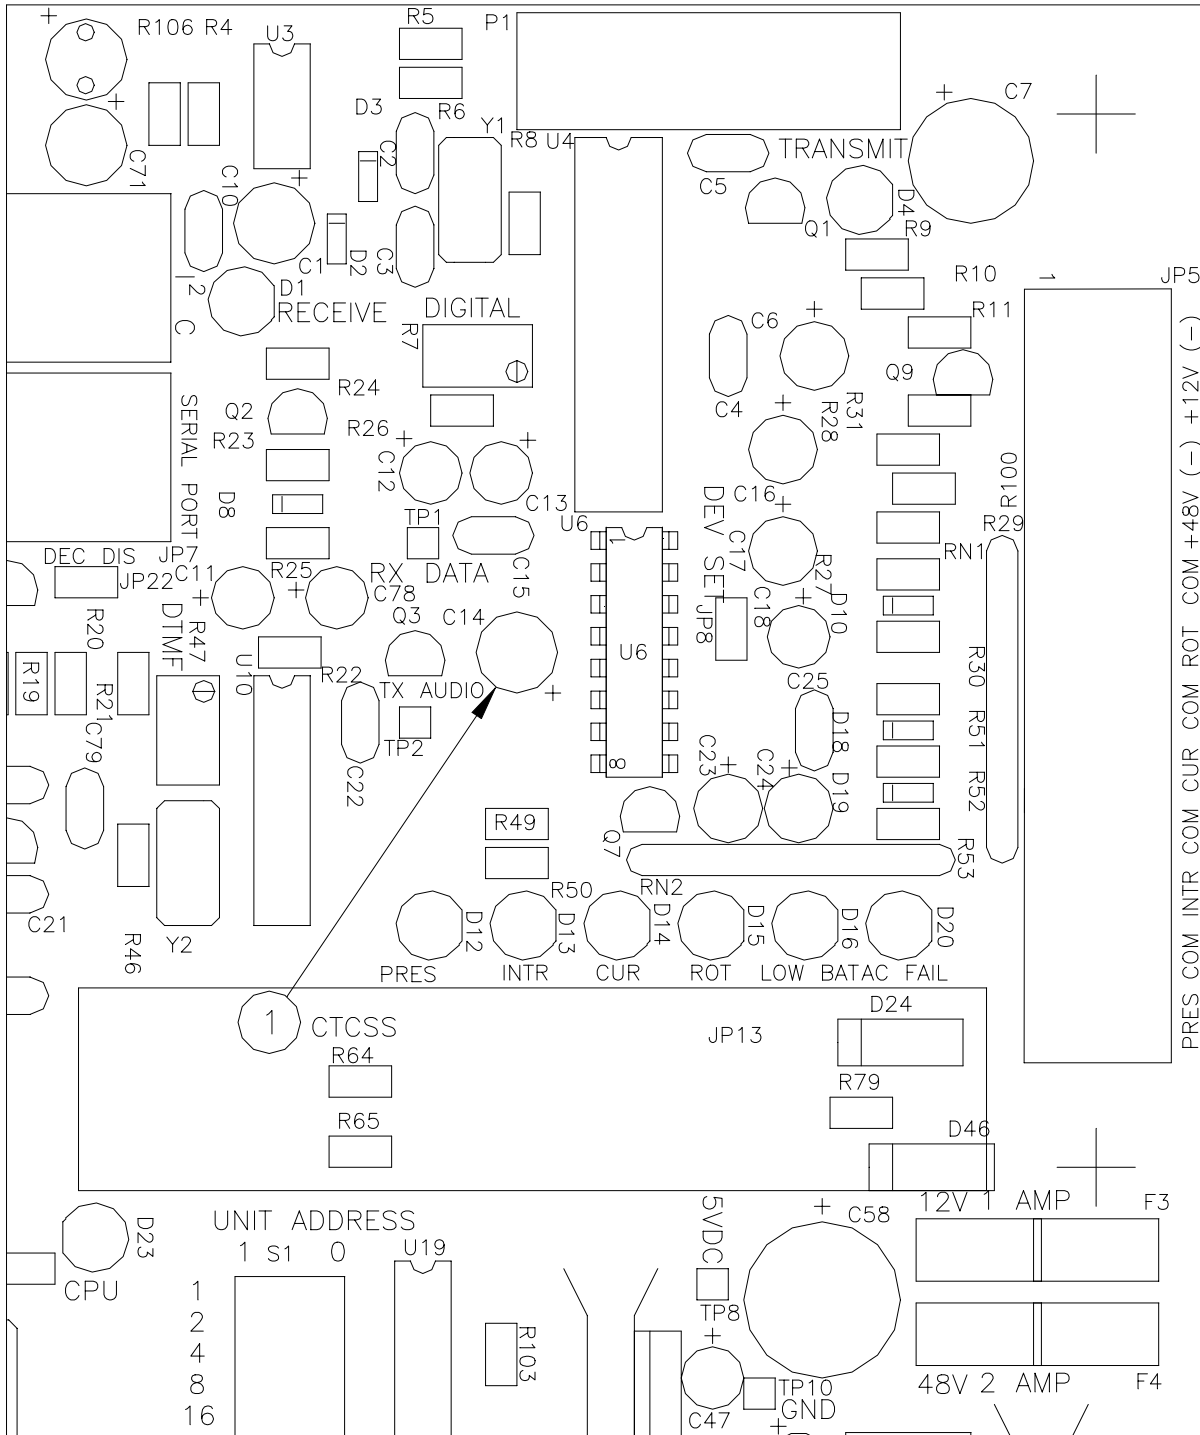
If the controller board has not transmitted recently, then the first transmission may be distorted. Transmission is within specifications by the third transmission.

The transmit output cap C71 charges slowly causing the transmit audio amp in the transceiver to be biased off or near one power rail until the cap charges to the same level as the transceiver's transmit audio circuit. This distorts the transmit audio rendering it un-decodable. After multiple transmissions the DC level settles and the transmission is OK. This incorrect charging was due to leaking capacitor C14.

- 1) Replace C14 with capacitor(1071226A) 0.1uf cerm. 100V, 10%
